Collapse of 4 storied building in Begunbari---A pictorial case study

Md. Nurul Alam Project Coordinator/Structural Engineer,
ADPC

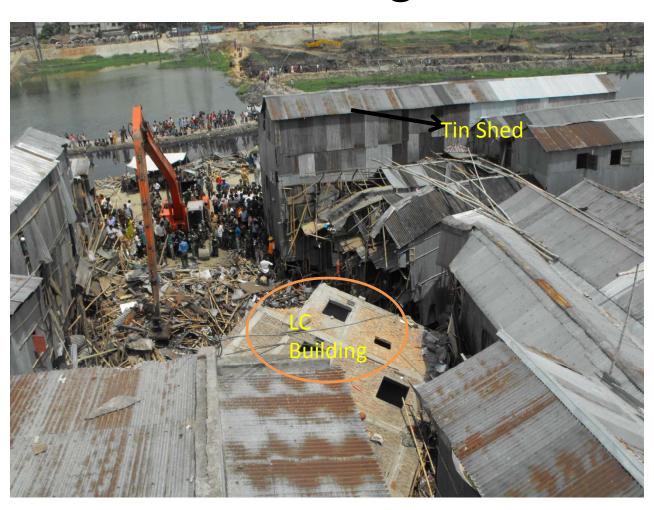
LC building collapsed on a tin-shed building

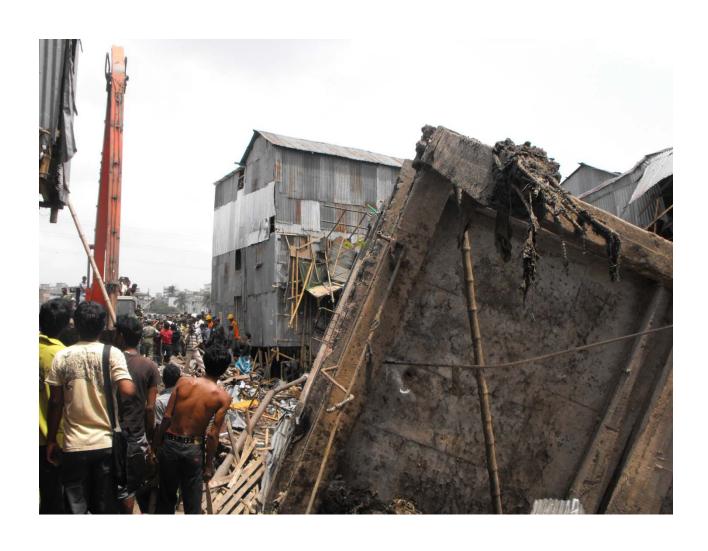
Missing of Sufficient Ties in columns

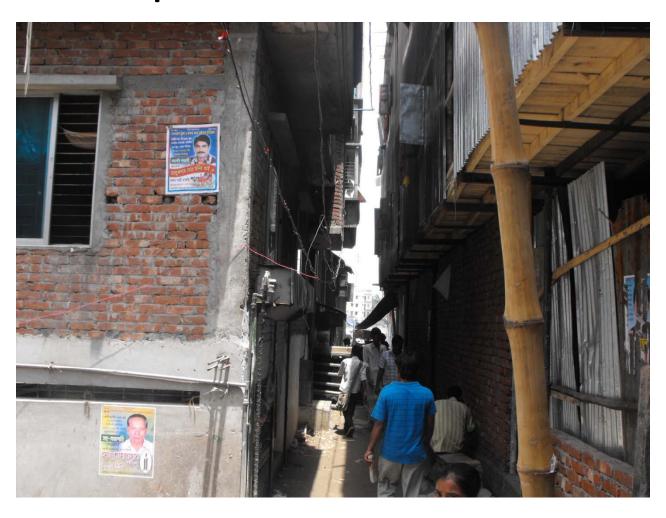
Narrow Access route made the response work difficult

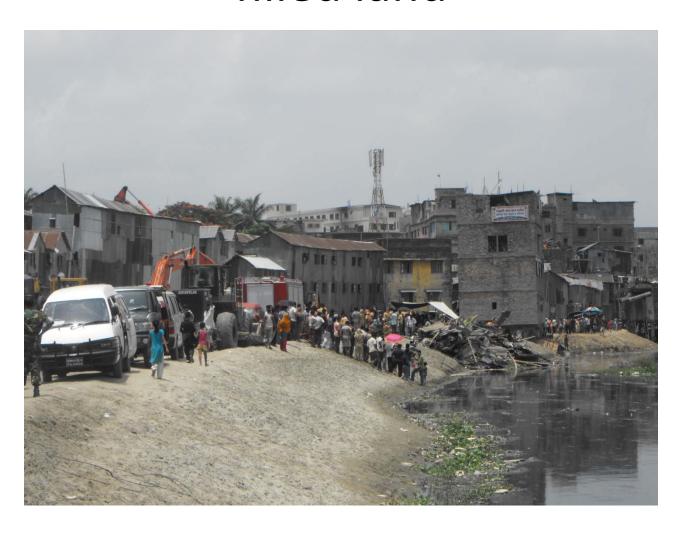
The Structure was built on a recently filled land

- Improper site selection, even the land was filled with garbage instead of soil.
- Some heavy construction material were stored in the top floor of the building, which might lead the collapse.
- Low stiffness of the ground floor (GF soft) might lead to the collapse.
- Foundation was not designed properly and the connection between the column and the base was not adequate.

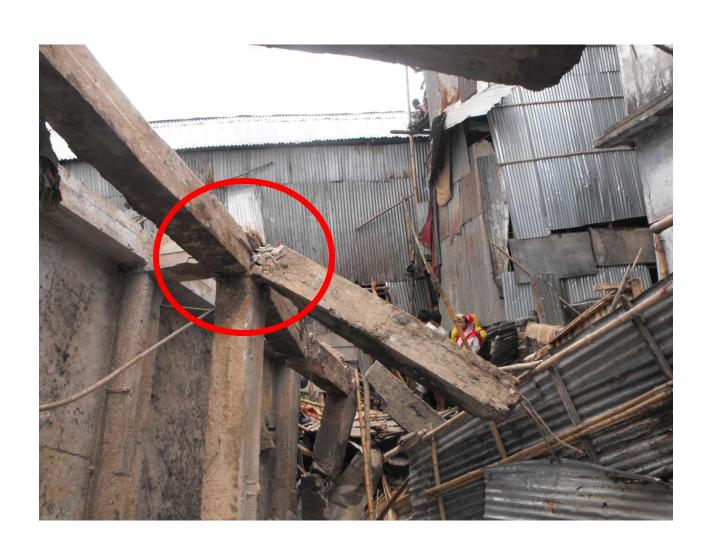
(Ground Floor)Soft Storey Effect!

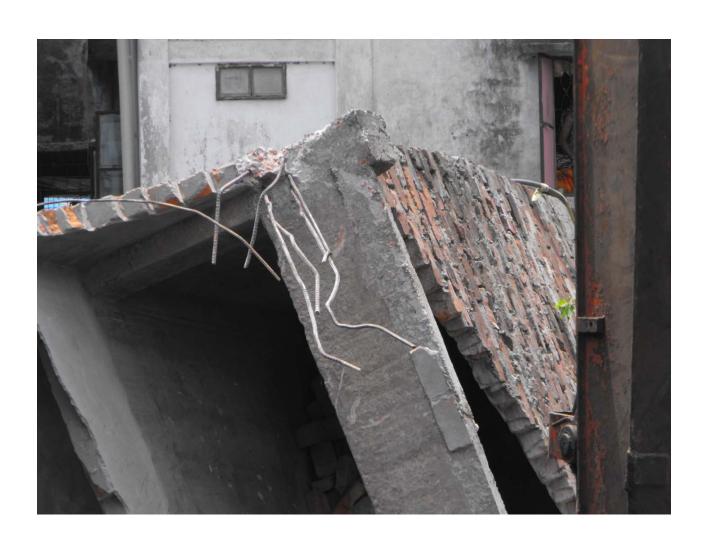
Bad Choice of Construction materials

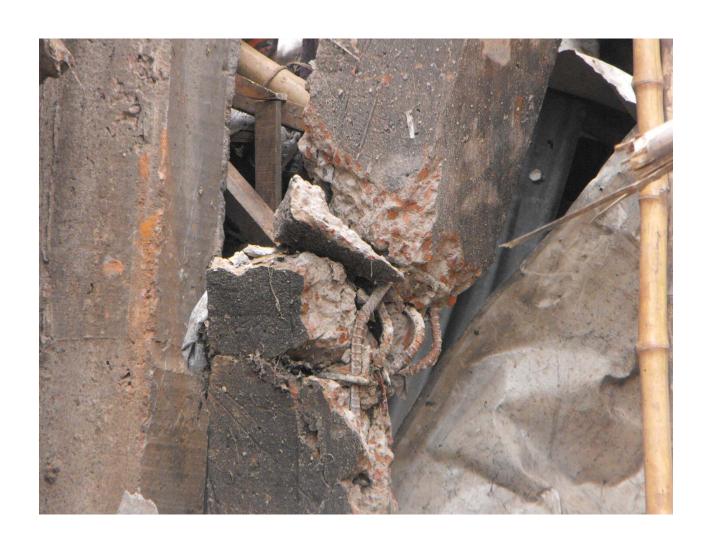
Brittle failure

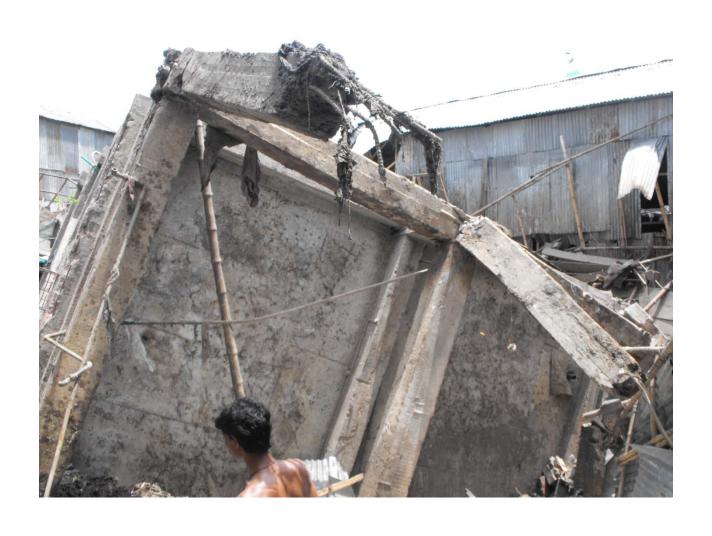
Bad connection to the ground

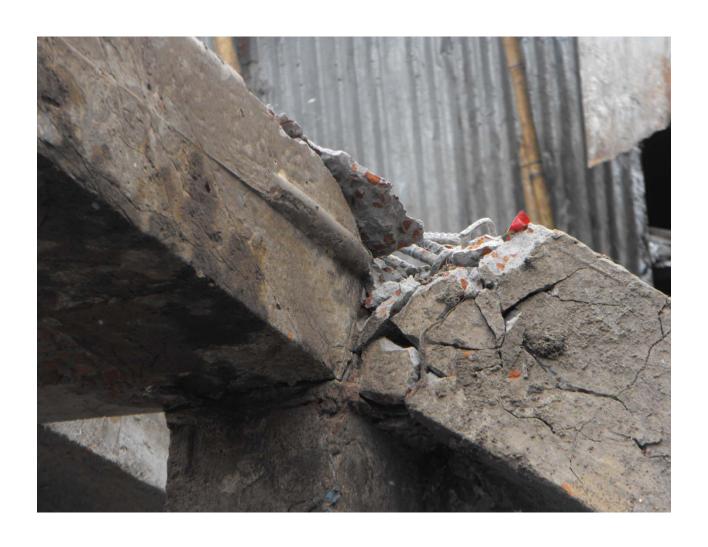
Short Column Effect

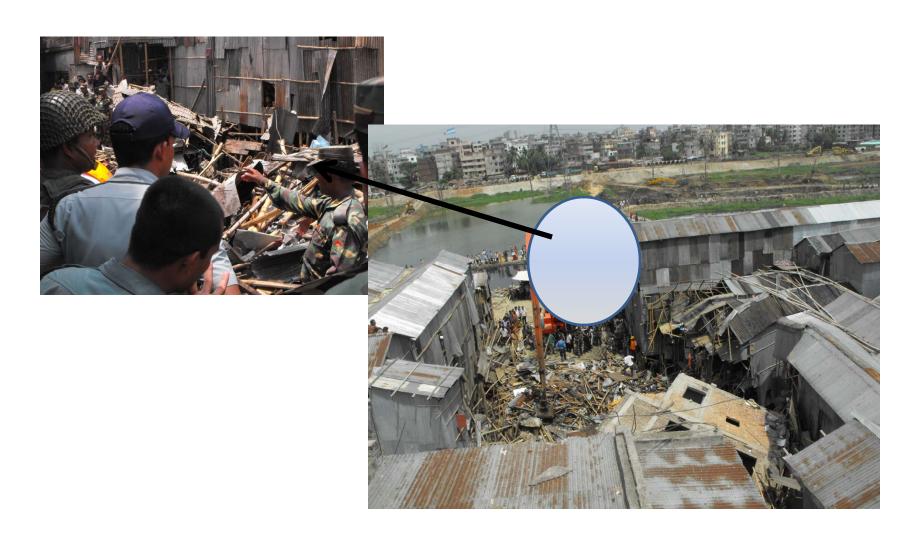
FSCD, Police, AFD, BDRCS, Ansar, community volunteers all were involved in the S&R operations, but still the collapsed building could not be removed.

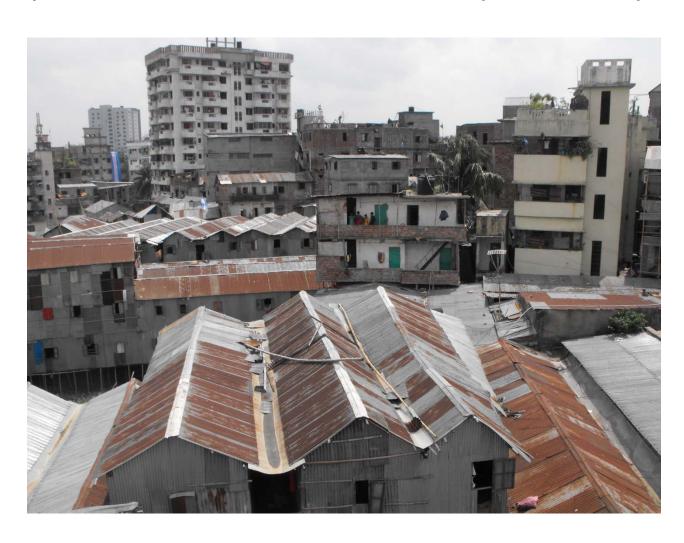
It is not a special case in the area. Still there are so many vulnerable structures in the particular place!
