RAPID ASSESSMENT

**FLASHFLOOD AND LANDSLIDE DISASTER IN
THE PROVINCES OF UTTARADIT AND
SUKHOTHAI, NORTHERN THAILAND, MAY 2006**

June 2006

RAPID ASSESSMENT: FLASHFLOOD AND LANDSLIDE DISASTER IN THE PROVINCES OF UTTARADIT AND SUKHOTHAI NORTHERN THAILAND

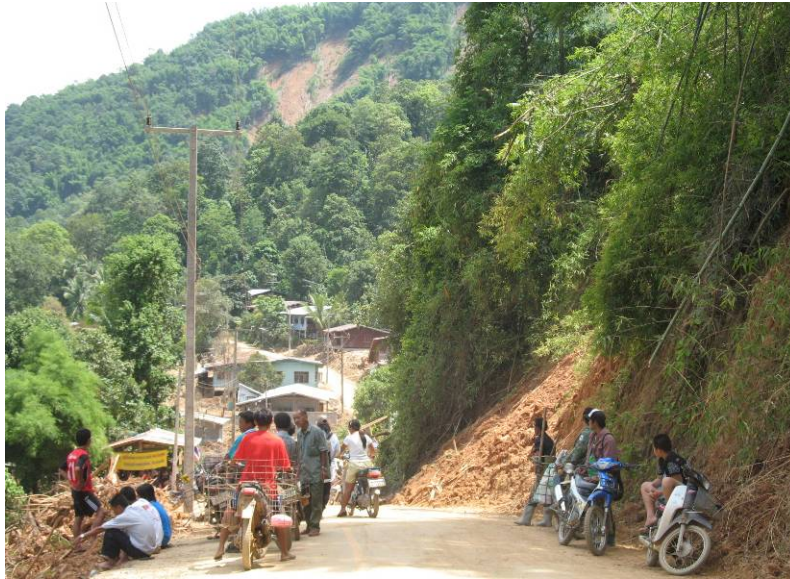
Few houses have been constructed on hill slope in the immediate neighborhood but not on the high slopes. However they have not considered the appropriateness of the location with regard to risk potential when selecting the location for the house. Therefore some houses have been destroyed due to slope failures while some others located on or in the vicinity of dry streams were destroyed due to gully erosion or debris attack coming through the gullies

Figure 4. Poor practices of settlement: construction of houses on hill slope

1. *Hazard mapping and selection of suitable safer location for reconstruction of houses destroyed by the event as a first step in the recovery program.*

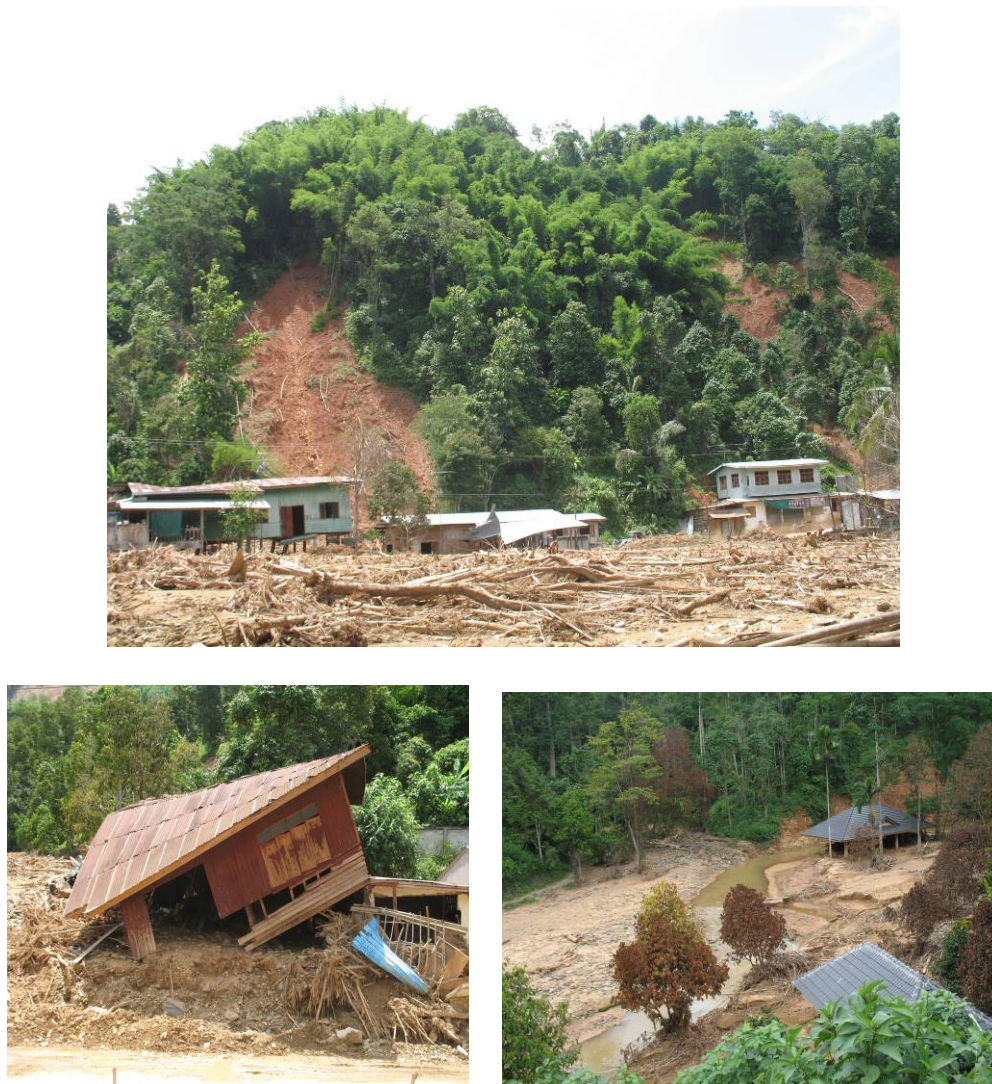
Traditional practice of housing on stills has helped to great extent to reduce the losses of life. As per the views of the communities affected most of them were evacuated when the floodwaters came to the community but houses have been destroyed due to subsequent debris flows and flash flood currents. However some of the modern houses have not adopted the ancient practice of construction on stills and suffered heavy destructions.

Figure 5. The destruction of traditional houses due to slope failures (above) and its proximity to the streams.

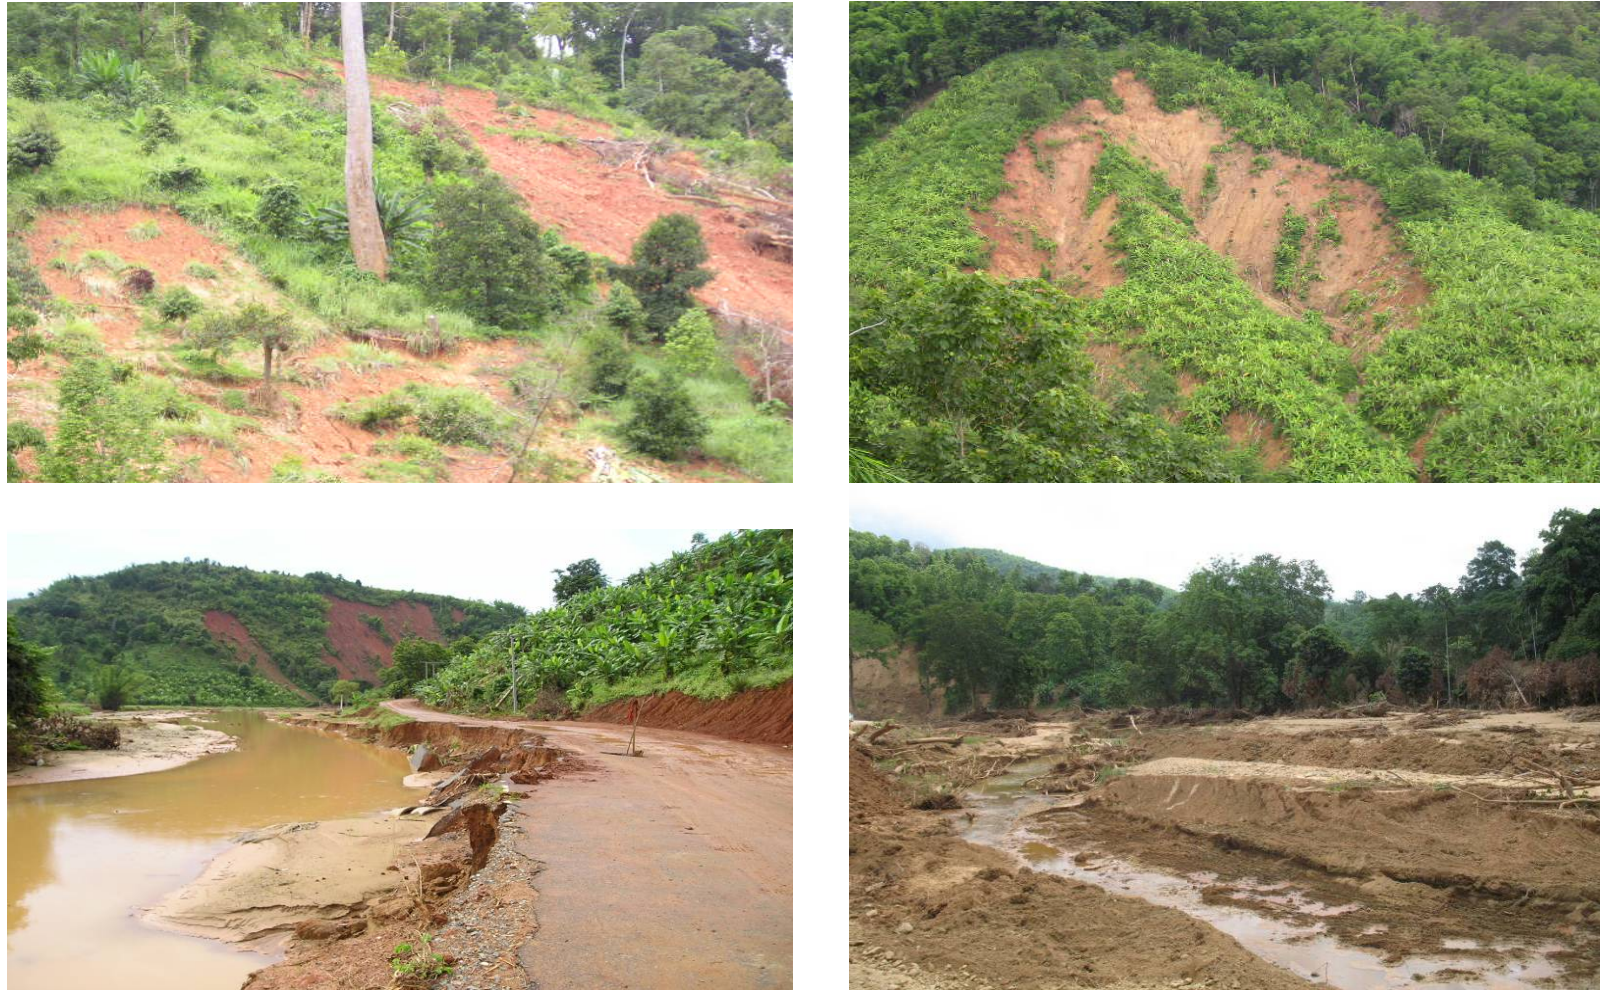
The slopes, which were subjected to destabilization and inspected by the team, suggest that the landslides, which were inspected during the field visit, can be categorized in to:

- a.) Shallow earth slips
- b.) Gully erosion
- c.) Failures of cuttings behind the houses or roadside cuttings.
- d.) Slope or bank failures due to erosion of the foothill and destabilization of upslope area.

Figure 8. Categorization of the inspected landslide (a) Shallow earth slips (b) Gully erosion (c) Failures of cuttings behind the houses or roadside cuttings and (d) slope or bank failures due to erosion of the foothill and destabilization of upslope area.

Out of above four categories shallow earth slips are the predominant category and about around 80 % of failures falls within that category. Shallow failures have occurred due to saturation of the topsoil layer to a depth up to 30-40 cm. Very rarely thickness exceeds 40 cm. Most of the failures are attributed to slopes with poor vegetation cover or vegetation cover with poor root system such as banana, wild bamboo.

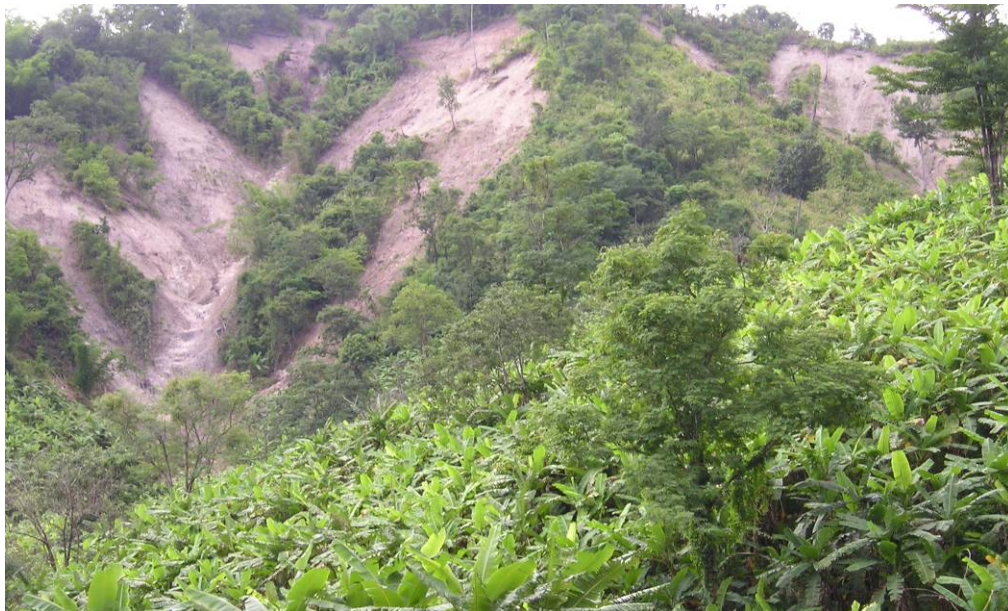
The sloping land in the vicinity of the flood affected areas has been used for cultivation of various crops by villagers for a considerable time. The destabilized slopes are mostly abandoned land after farming on slopes or deforested land for commercial purposes. Lately such slopes have been covered with inappropriate types of vegetation such as banana, wild bamboo etc. Farmers usually practice slash and burn methods for farming on slopes without proper understanding of slope degradation and potential for slope destabilization. Although few decades ago it did not yield serious consequences due to rareness of the activity, continuation of such practices by many villagers, currently and frequently result in serious consequences as with the population increase, more people tend to get involved in such practices

Figure 9. Slope destabilization due to the change of forest into banana plantation.

It is necessary to revisit the policy on land use planning in mountainous areas prone to landslides and flash floods. The present land use observed in the area is not conducive and slope destabilization, land degradation and high erosion are connected with the current land use practices. It might also better if a reforestation program can be initiated on vulnerable slopes to prevent further land degradation. If the rice fields and farm areas are getting affected in the long term perspective it can have serious effect on livelihood options of the population living in the affected areas. Recovery programs also should consider not only the replacement of destroyed facilities, housing so on but also livelihood since most of them will have further sufferings due to destructions to farm areas and impact to the livelihoods.

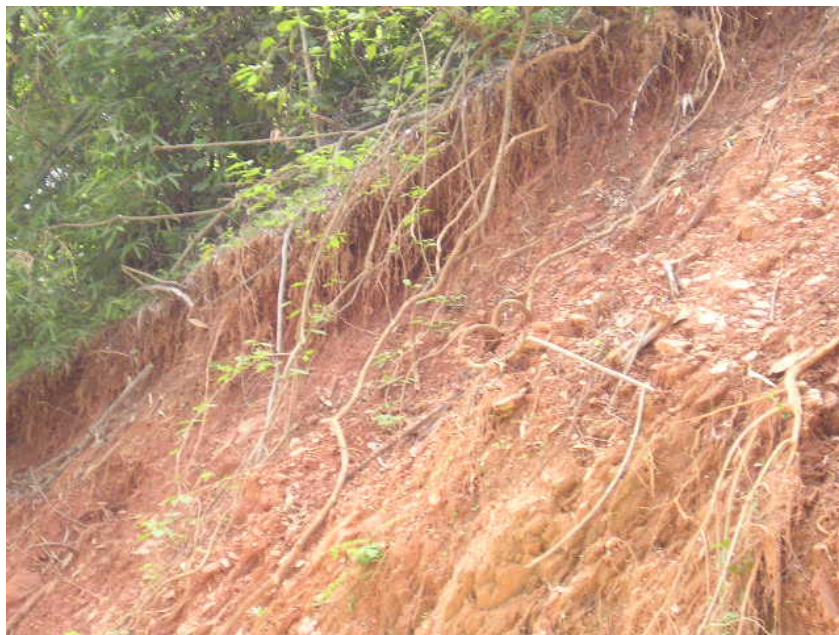
Figure 10. Slope degradation due to weak vegetation cover.

Most of them do not know the ill effects of such disturbance to slopes and vegetation. Therefore this has to be handled through programs for creating awareness on ill effects and exercising control through land use policies on usage of slopes within a catchment for reduction of risk to communities living in flood plains.

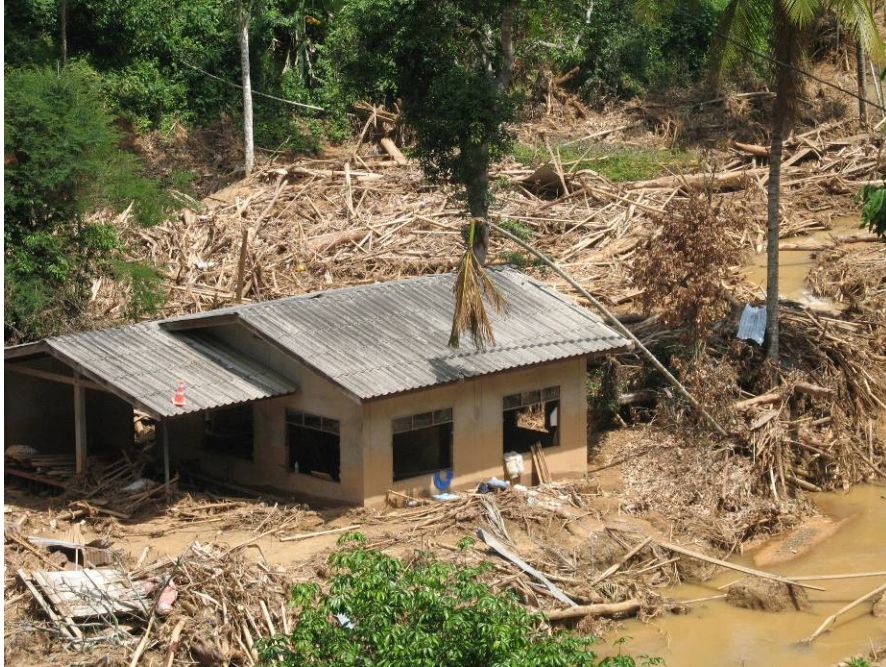
Many houses have been destroyed due to flash flooding and due to the lethal attack associated with accompanied debris. Mostly debris consists of timber logs, tree branches and uprooted trees of different

sizes. The mass of debris has been created by destabilization of slope, the sub soil layer and vegetation over the same and transportation it by the floodwaters.

Figure 11. Mudslides consisted of rocks, earth, uprooted trees and other debris. The flood removed the top soil due to the unstable slope and weak vegetation cover thus the land being eroded and transported into the stream.

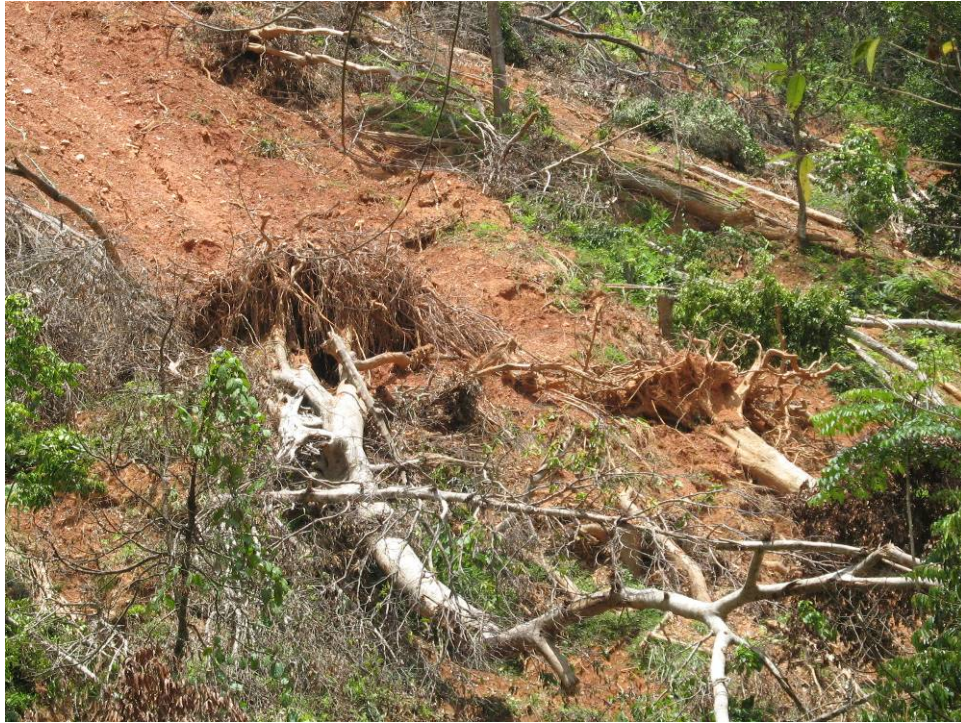
Destruction of the subsurface layer due to erosion can take place by repeated action of raindrops on soil particles. The energy in a raindrop dislodges soil particles and moves them with the flowing water over the soil surface. A range of factors including soil texture, degree of

compaction and chemical composition affects the soil permeability. The rate of which soil infiltrates in to soil depends on soil water content, texture, density, organic matter content, hydraulic conductivity and porosity. The slope destabilization take place due to loss of strength of the soil layer and downward movement due to gravitational force.

Figure 12. Destruction of the subsurface layer due to erosion, after the repeated action of raindrop on soil particles.

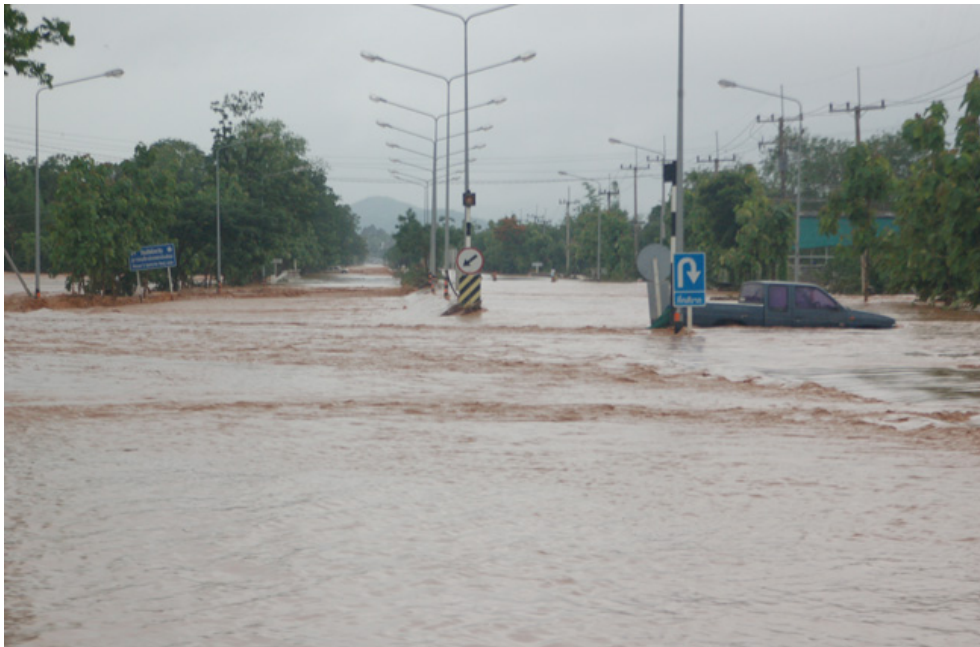
The city of Uttaradit and few other urban areas located in the flood plain of the Nan River were inundated due to the heavy rain associated with the events described above.

Figure 13. Flash flood due to heavy rainfall overflowed the floodplain of the Nan River, including city of Uttaradit (Source: Uttaradit Province website)

But since the urban area is located further in the catchments the impact only caused due to flash flooding. There was no impact from debris flow and flooding has caused more damages and losses to shops, commercial ventures and household items such as furniture, electronic items so on. The city transportation system, water supply, sewerage and drainage systems also were subjected to severe destruction or failure of functioning due to the event. The event has shown the vulnerability of Uttaradit city and other urban areas in the catchment area of Nan River located in the affected provinces.

The flash flooding in urban areas within the Nan river catchment suggests the importance of setting up Urban Emergency response mechanisms. It should include training medical first responders, urban search and rescue teams, development evacuation systems, response plans and so on. DDPM is having plans for setting up such systems at present. Nevertheless, it will be better to involve not only the district authorities but also the local government level officials in setting up such systems.
